NATIONAL COMMUNICATIONS SYSTEM

TECHNICAL INFORMATION BULLETIN 88-3

THE EFFECTS OF HIGH-ALTITUDE ELECTROMAGNETIC PULSE (HEMP) ON TELECOMMUNICATIONS ASSETS

JUNE 1988

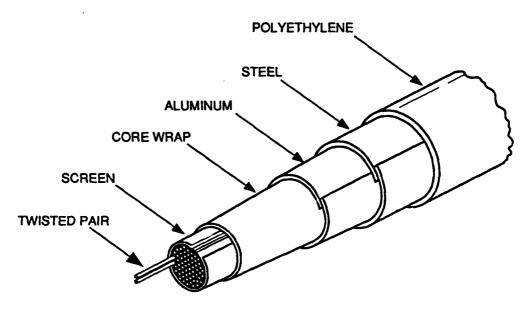
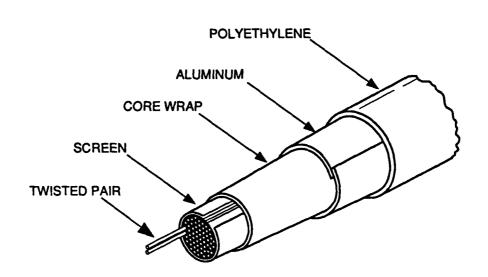
Exhibit 2-2 T1 Carrier Twisted-Pair, Screened Cables

In a typical T1 cable in the field, proper EMP cable shielding techniques are not always followed (i.e., the cable sheath is not always continuously bonded). The major violation occurs at cable splice points. In a typical plastic splice case, a copper braid makes a DC sheath-to-sheath connection for safety purposes; running alongside unshielded signal leads. Even when a steel splice case is used, a bonding jumper is carried inside the case. Three common splice cases are shown in Exhibit 2-3. Pigtails (bonding straps) are not usually well-bonded to sheaths, do not provide enough surface for conduction of large amplitude surges, and easily degrade over a period of years. The design of such splice cases allows significant coupling of the sheath current to the signal conductors.

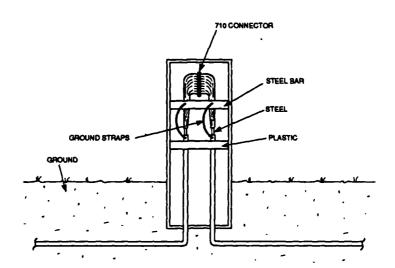
(c). PC-12 Splice Case

A theoretical prediction of currents induced on a long cable sheath with splice cases inserted has never been performed. Actual long lines cannot be illuminated experimentally, but it is reasonable to assume that actual amplitudes would not be higher, and actual rise times would not be faster, than those calculated for cables without splice cases. However, a few splice cases that allow enhanced coupling to signal leads could cause significantly higher HEMP transients at terminal equipment.

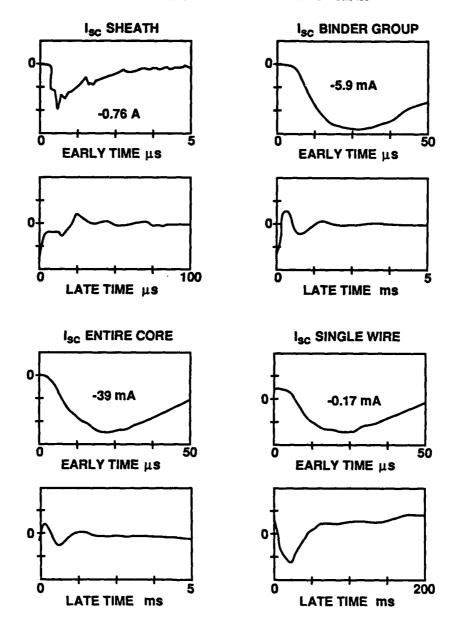
Exhibit 2-4 HEMP-Induced Currents on Buried T1 Cables

SHEATH \Rightarrow CORE \Rightarrow BINDER GROUP \Rightarrow WIRE 760 mA \Rightarrow 39 mA \Rightarrow 5.9 mA \Rightarrow 0.17 mA SHEATH/CORE \sim 20/1 CORE/BINDER GROUP \sim 7/1 2.1.1.2 <u>Aerial T1 Cable Test Results.</u> In the aerial T1 Carrier Study, two 100-foot 106-pair cables were pulsed with a 3 kV Marx-type current pulser at HDL. A decaying exponential current pulse of 1.6 kA peak amplitude was first injected on the sheath of the cable without a splice case. This current induced between 600 and 700 mA on individual signal leads. When extrapolated to a 2 kA sheath current, between 750 and 875 mA should be induced on individual signal leads. The Buried T1 Carrier Study indicates that a 2 kA sheath current will induce about 500 mA on individual signal leads of buried T1 cables. The higher aerial T1 signal lead current is consistent with aerial cable construction, because aerial cables do not have an outer steel casing, thus allowing a more direct coupling from the sheath current on the aluminum screen to the individual signal leads. When a splice case was added in-line with the cable, the same 1.6 kA sheath current induced between 15 and 23 A on the individual signal leads.

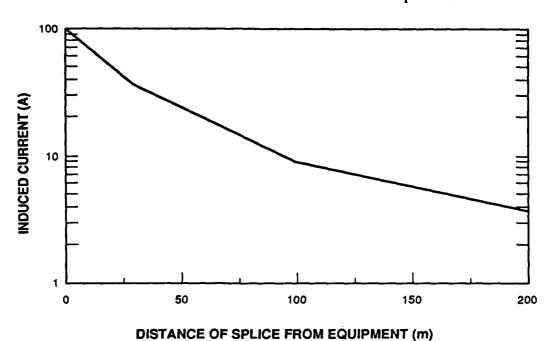
Exhibit 2-5
HEMP-Induced Currents on Aerial T1 Cables with Splice Cases

A major emphasis of the Aerial T1 Carrier Study is the prediction of currents that would couple to the internal conductors of the cable as a result of in-line splice cases. Exhibit 2-5 shows the predicted HEMP-induced current as a function of splice case distance from T1 equipment. With splice cases less than 10 meters from the equipment, worst-case currents of 100 A may reach the equipment. With splice cases more than about 300 m from the equipment, only about 1 A may reach the equipment.

2.1.1.3 T1 Cable Test Results Summary. The Aerial T1 Carrier Study concludes that worst-case currents of 100 A may reach T1 equipment from aerial T1 lines, if the equipment is located within about 10 meters of a splice case. Using splice case data generated in this study, it can be assumed from tests conducted in the Buried T1 Carrier Study that worst-case currents of up to 50 A may reach T1 equipment from buried T1 lines, if the equipment is also located within 10 meters of the equipment.

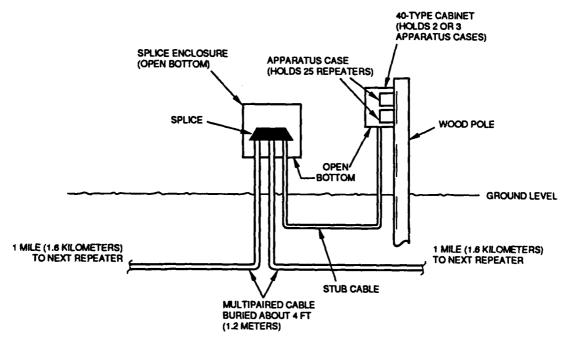
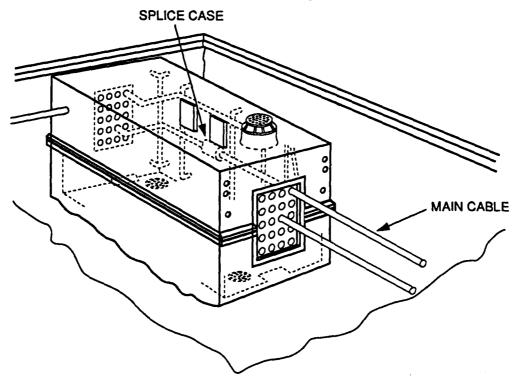
Exhibit 2-6
Typical Buried T1 Repeater Installations

Operation (AESOP) and Office Sinusoidal Simulator (OSSI) combination to pulse fields onto a 2,000-foot T1 trunk with a splice case and pole-mounted repeater at its center. In this test, high-level fields and induced lead currents were simultaneously directed onto the repeater. A lightning-protected repeater and a special EMP-hardened repeater were tested, but only the lightning-protected repeater tests are discussed here.

The typical repeater unit tested is an 800-type plastic case housing two 239 E/F 60 Hz protected repeaters with standard lightning protection devices (208A gas tubes) installed. The splice case is a typical PC-12 mounted above ground. During testing at several field levels up to threat level (about 50 kV/m), outages in equipment operation of 61 μ s to 256 ms were experienced, but no permanent failures were observed.

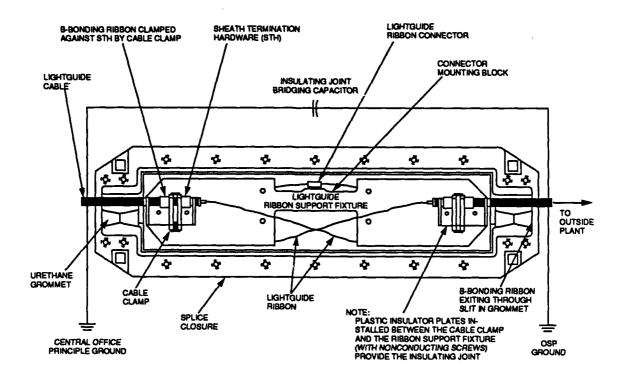
Exhibit 2-18
Grounding and Insulating Joint Connections on Lightguide Splice Organizer in a Vault Splice
Closure and at a Central Office CEF

The splice and optical cable were subjected to injected currents above the predicted threat level of 700 A, with no parity errors detected. The 900 A injected current waveform probably caused some physical damage to the cable, because induced current transients of only 475 A were shown to cause minor damage to the outer sheath of the cable. Despite this probable damage, it appears that the cable and splice case are survivable to the effects of HEMP, because the optical signal was not disrupted due to the injected current.

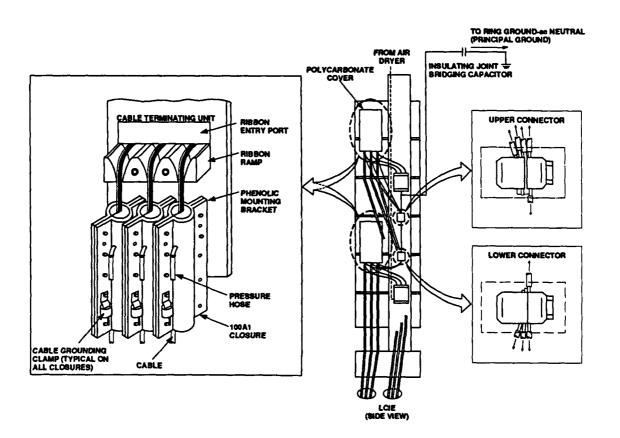
Exhibit 2-19
Detail Views of Cable Terminations on Lightguide Cable Interconnection Equipment

The large current transients that are generated on the steel strengthmembers of the FT3C cable may enter the LRS through the ground system (which incorporates both the LRS and the LCIE), because the current is terminated to ground through the LCIE. The FT3C power system may be susceptible to spurious shutdown or hardware damage when exposed to these transient ground-system currents.

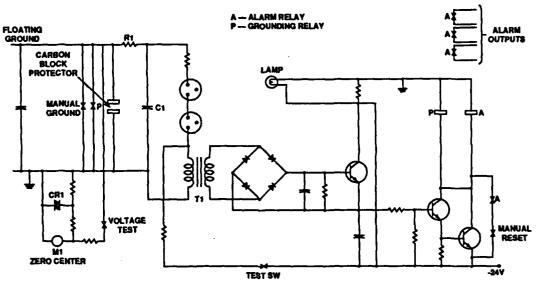
Exhibit 2-32
Schematic of Power Loop Protective Grounding Circuit

At the higher stress levels the L4 system was susceptible to shutdowns at the power system due to overcurrent and undercurrent effects. Such an occurrence can be deemed a failure because manual intervention was required to restore system operability even though there was no physical damage. Such manual intervention might be impossible during NSEP conditions.

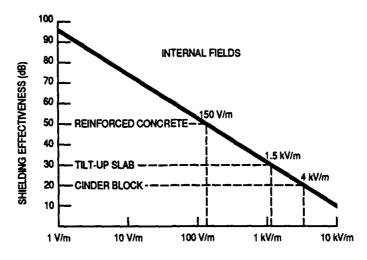
Exhibit 3-1
Building Shielding Effectiveness

The high-altitude EMP threat presents a peak electromagnetic field of about 50 kV/m. Given this external field, Exhibit 3-1 presents the field environment inside the walls of a central office as a result of shielding provided by the three types of construction. For example, a reinforced concrete building could reduce the fields inside the walls of the CO to about 150 V/m.

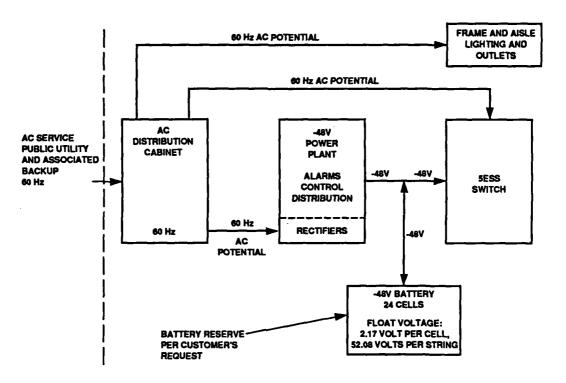
Exhibit 3-7
Power System of the 5ESS Switching System

Several pulses above 50 kV/m caused the failure of several power diodes in the rectifiers, leaving the affected rectifier(s) inoperative. One test pulse caused the AC circuit-breakers of all three rectifiers to trip, resulting in a switch to battery power. Every DC-to-DC power converter in the 5ESS switch also shut down, causing the operation of the entire switch to stop. The diode failure was probably in response to voltage transients which exceeded the 200 V Peak Reverse Voltage (PRV) rating of the diodes. Diodes rated at 800 V PRV were installed, and the modified rectifiers were exposed to pulses at ALECS up to 80 kV/m vertical without a single diode failure or power shutdown, although they were never exposed to the horizontally-polarized fields of the HPD. The massive power-down shows that the unmodified

rectifiers cannot be considered survivable to the effects of HEMP. Even a switch to battery power is unacceptable, because the batteries will only provide power for about eight hours. Backup generators can provide power after the batteries fail, but the generators will run out of fuel in several days. If the failed rectifiers are not repaired before the generators run out of fuel, operation of the entire 5ESS switch will cease.

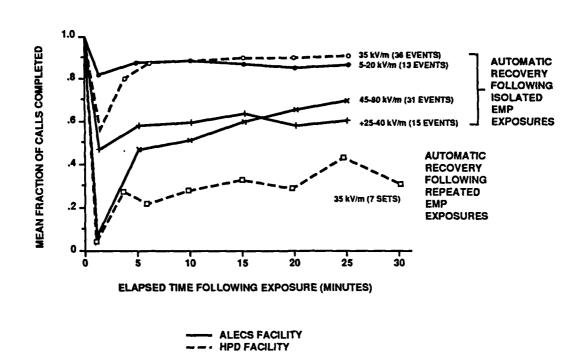
Exhibit 3-9 summarizes the 5ESS switch steady-state test results that should be used by the OMNCS as inputs to the BSM for network connectivity assessments. Each data point in the exhibit represents the total fraction of pulses at a given field level for which the switch returned to the given percentage of active call processing. For example, following 2 out of the 13 test pulses at 10-30 kV/m, the switch reached a steady state active call processing of 85 percent. This data format more accurately reflects the response of the switch than data formats from other test programs, because the 5ESS switch never returned to full operating capability following exposure to simulated HEMP fields. Testing under the ALECS simulator was

(a). Mean Fraction of Preset Calls Dropped Due to Induced Transients

(b). Automatic Recovery of Call Processing Following Simulator Exposure

Although the switch did not have a single physical failure at any of the simulated HEMP exposures, careful interpretation is required in using these results. It must be stressed that the results presented in Exhibit 3-9 are for a 5ESS switch incorporating the hardware modifications outlined above. All these modifications, with the exception of the optical link to the MCC, will be incorporated in new 5ESS switches. As mentioned above, some form of upset occurred at all levels of testing: a significant fraction of calls were dropped, call processing capability was reduced during fault recovery, and automatic restoration of all switch resources was not fully completed. Despite these upsets, the hardware failures experienced did not affect call processing capability. The optical link to the MCC will not be a standard offering on future 5ESS switches. Damage to the TTY interface caused by current transients on the MCC cables would not affect call processing ability of the switch, but personnel at remote sites would not be able to control and monitor the switch after a HEMP.

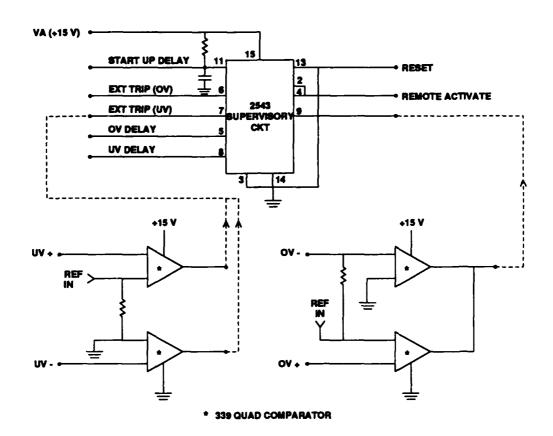
Exhibit 3-14
Power Converter Monitor Module

Prior to testing of the unshielded switch under the AESOP simulator, the sensitive supervisory chip was replaced by a less sensitive chip produced by another manufacturer to preclude manually resetting the switch after each test pulse. During testing at the 33 kV/m level, call processing continued to break down following each of the pulses. This problem was due to two effects: sensitivity of other supervisory circuit chips located in the LCM's power converter, and logic corruption in the PMs (e.g., LCM, LTC, & TM8). Call processing capability returned to full capacity through manual power reset and data downloading from disk. The affected chips were eventually replaced with less sensitive chips during testing at the 60 kV/m level at

AESOP. In addition, an "autoload" software pack was installed to provide automatic data downloading from disk. Four sets of multiple pulses (60 kV/m), ranging from 6 to 14 pulses per set, illuminated the modified switch, and call processing automatically recovered following each multiple set.

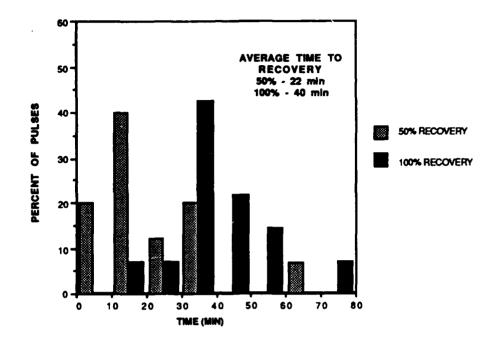
Exhibit 3-15
Recovery Time Distribution for 30-50 kV/m

Exhibit 3-15 graphically depicts the recovery time of switch call-processing capability following exposure to single simulator pulses of 30-50 kV/m. Exhibit 3-16 presents switch recovery time following exposure to single pulses of 50-70 kV/m. These exhibits include data taken from all the AESOP pulses for which recovery time data exist, with the switch in an unshielded configuration with modified and unmodified hardware. When one of the two LCMs (LCM0 or LCM1) returned on-line following a test pulse, the switch was said to be operating at 50 percent capability. When both LCMs returned on-line, the switch was said to be operating at 100 percent capability. This definition is entirely a function of the test architecture as described in Exhibit 3-13.
